## Technology Testimonial and Case Study

### Recompleting Oil Recovery Wells with Casing Cutter

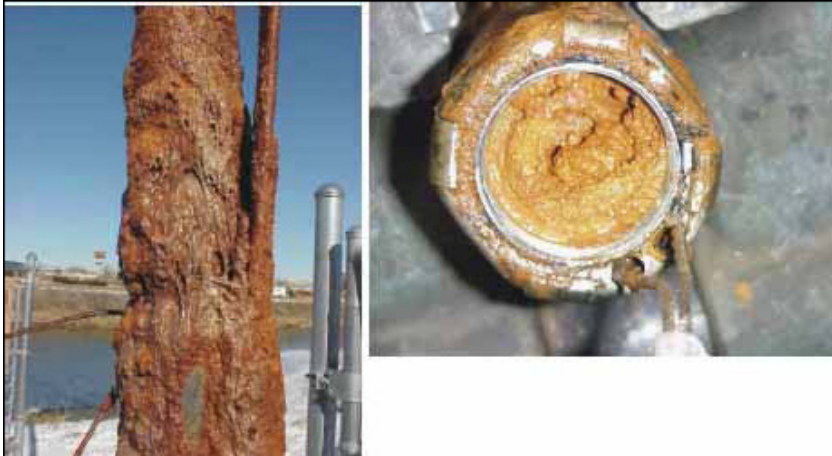
Shown at the far left is a photo of a stainless steel Grundfos submersible water pump. It is covered with an iron sediment bacterium that builds up in some of the recovery wells.

The right photo is the 2 inch discharge end of this same water pump. It is easy to see that the flow of water was seriously restricted.

The next application that was proposed to me by my supervisors was whether or not the Casing Cutter could be used as a preventive maintenance treatment to just this one well to prevent this type of buildup. This is an ongoing problem that requires additional maintenance to remove, clean, and reinstall equipment. Quite often, this buildup results in replacing equipment that fails prematurely.

Since this was a relatively new pump, it was scrapped, cleaned completely (with a sonic cleaner, and without benefit of a colloidal product because I was working on a different project elsewhere) and returned to service. For the next two months, I “slugged” this well once per week with Casing Cutter and this water pump was run continually at a flow rate of 25gpm. There was no noticeable reduction in the oil production of this well during the 8 week “slugging” process, using Casing Cutter. I used 1 gallon of Casing Cutter per treatment, and circulated the treated water back into the well via a 2 inch hose attached to the 2 inch discharge piping at the top of the well. I would circulate the flow of water back into the well for a period of 5 minutes with each weekly treatment.

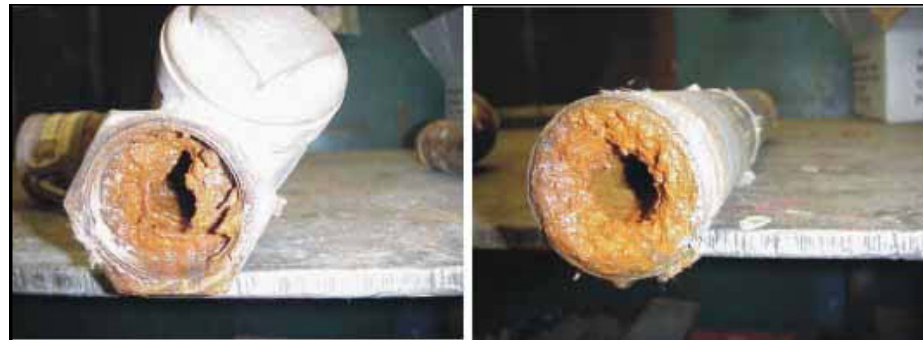
These photos show dismantling of the discharge manifold located at the surface above the submersible pump.

Note how the outside of the pump, the intake ports on the pump, the check valve and discharge line are all either covered or plugged with this buildup of iron sediment bacteria. This pump had been in service for less than one year.

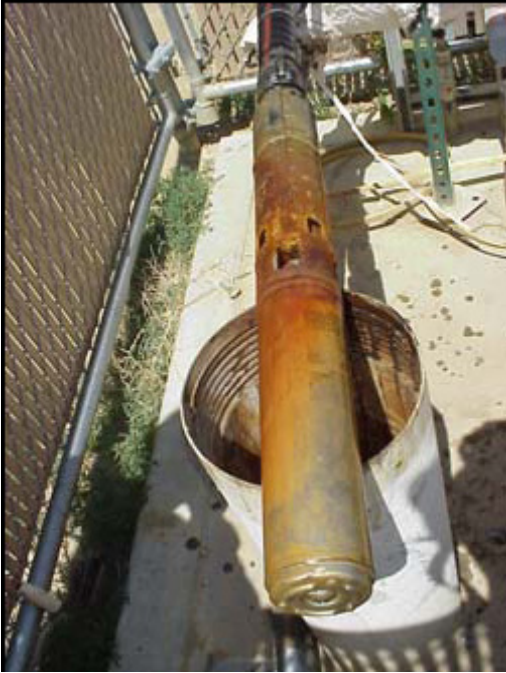
Here is a photo of the same water pump that is shown above after eight weeks of once-per-week treatments of Casing Cutter (a total of 8 gallons of product used during 2 months).

During the timeframe of this treatment test of this particular well, the water flow rate stayed at 25.953gpm without faltering even once.
